Cairngorm funicular railway: Written submission from Graham Garfoot, 17 December 2025

PAC MEETING SUBMISSION.

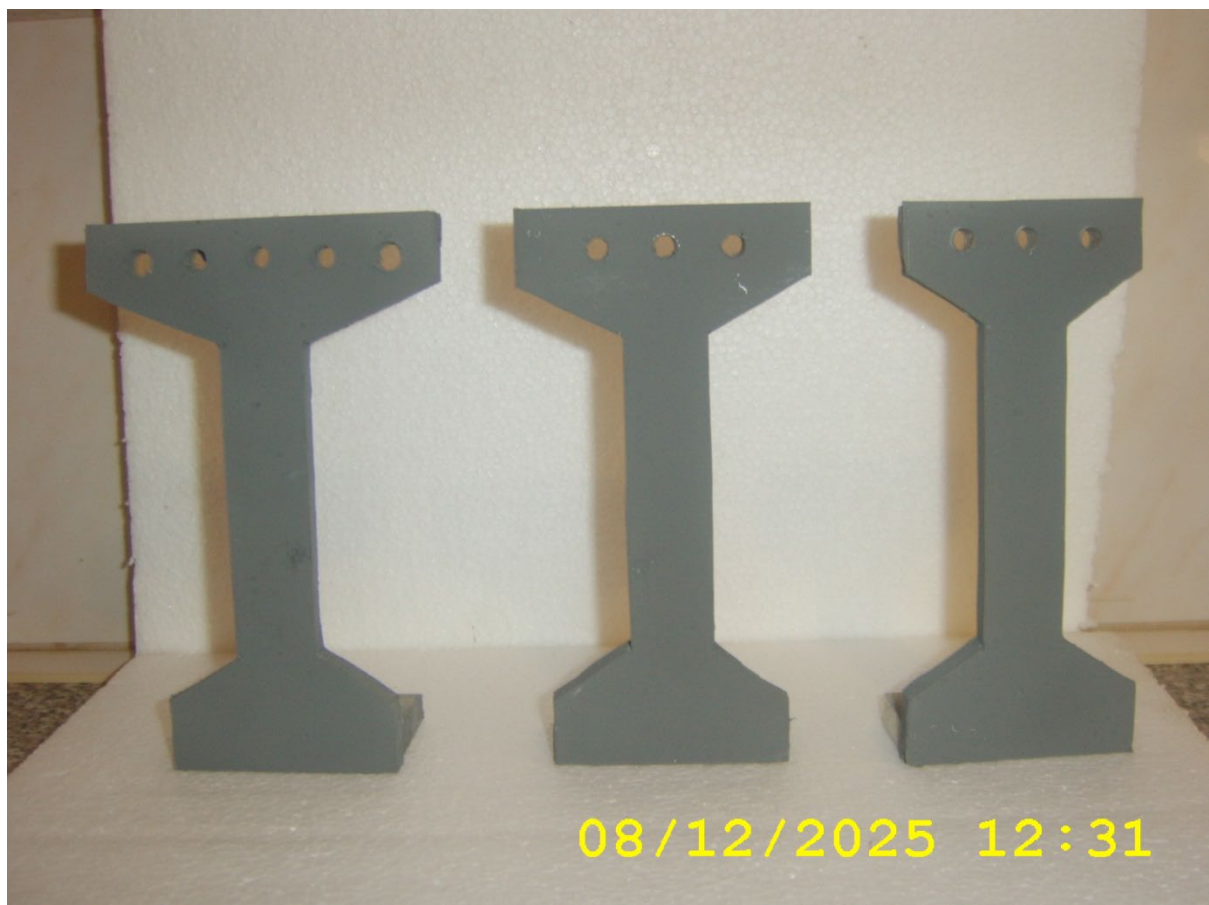
(1) The three different sized "I" beams in use,

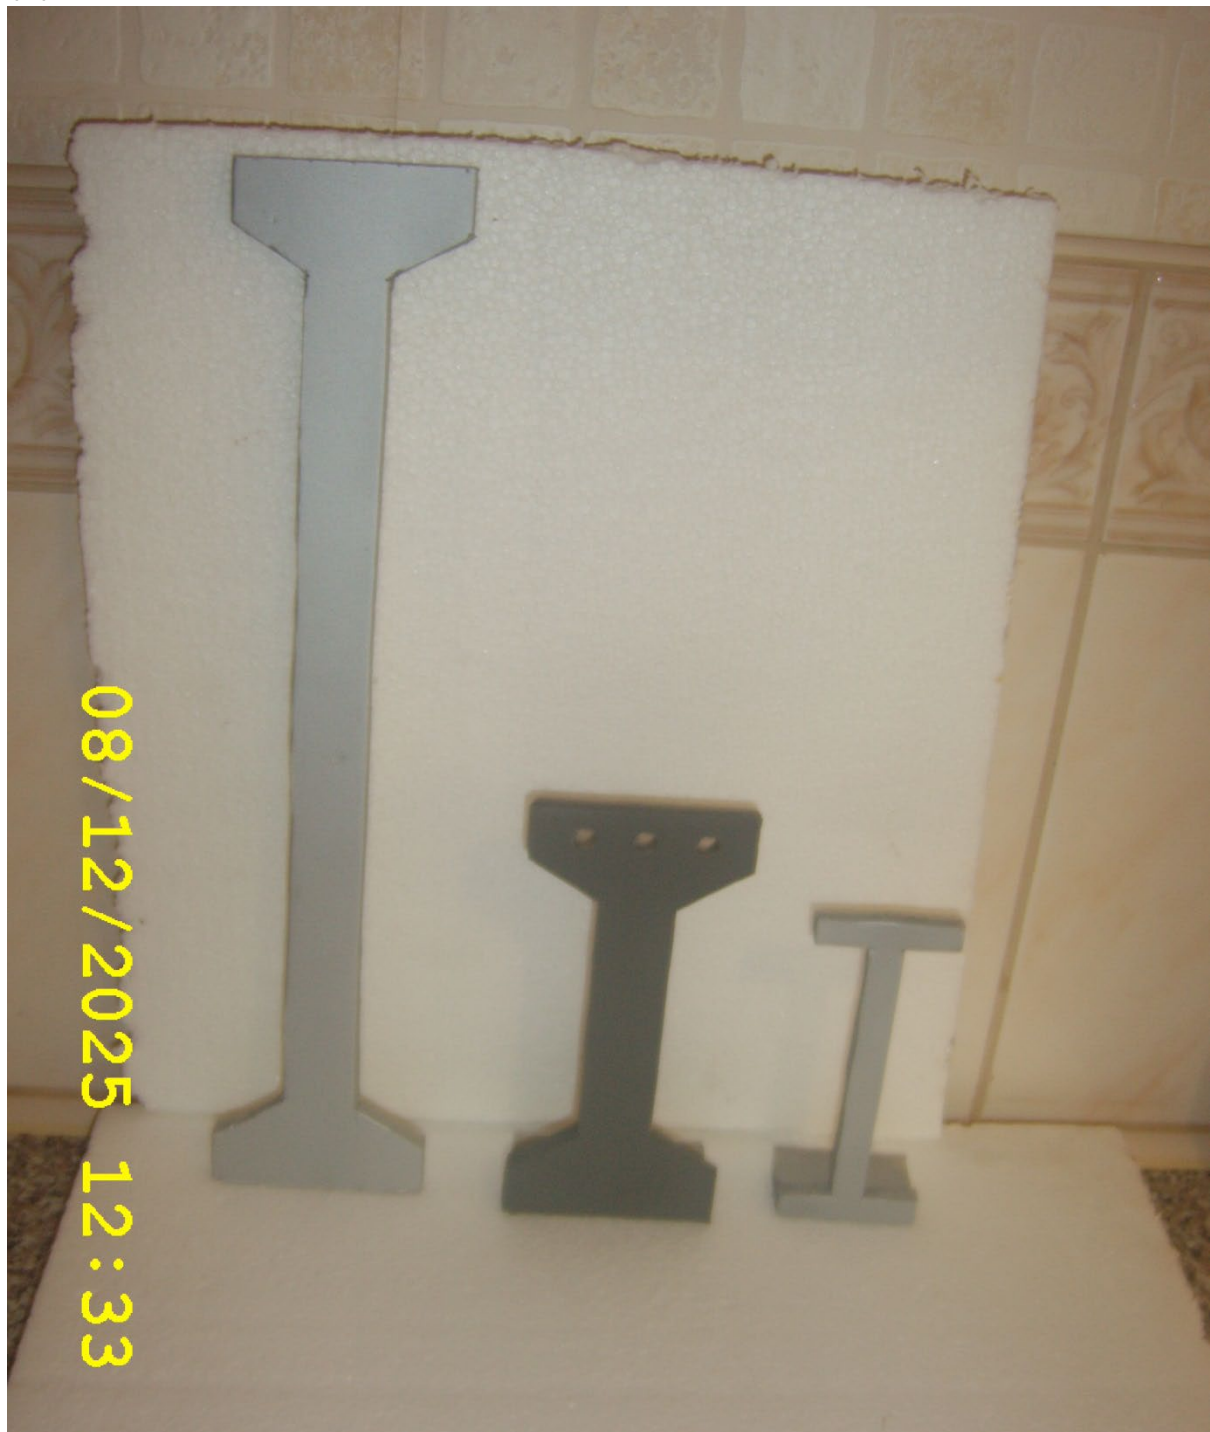
(2) For comparison

The larger model is of an “I” beam as recommended by a university rail lecturer and a senior civil engineer who has built bridges, while the smallest is of a steel beam as used on the Frachey funicular, next photo,

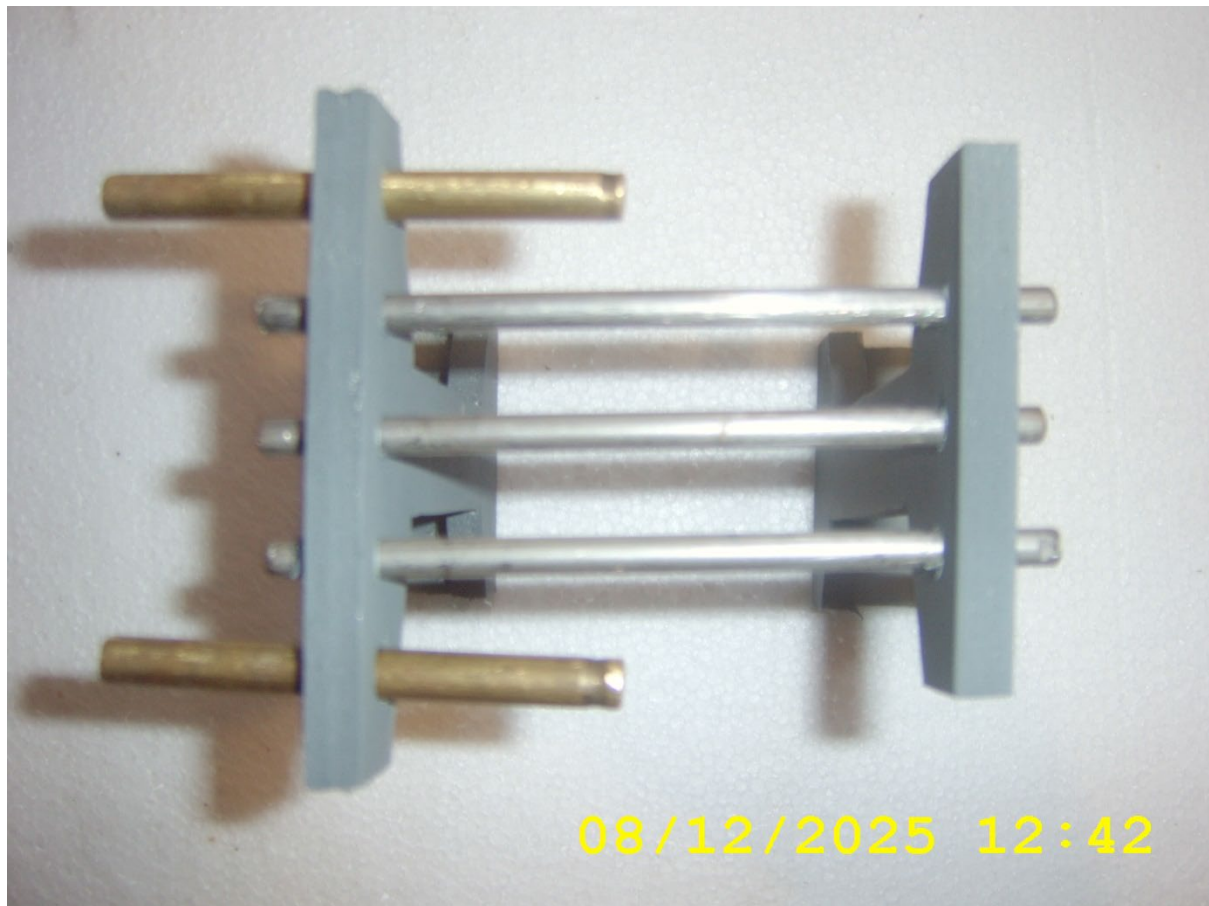
The next photo show stainless steel and brass rods made to the same scale, representing the reinforcing bar, or rebar as it is more commonly

known, and how the structure should have looked,

The left side model is of a Type 3 “I” beam with the right being of a Type 2 “I” beam. The outer two bars are obviously of a larger diameter than the other three. There are original drawings that show ALL of the rebars being the same size at 40mm! At some time again that specification was altered so that the inner bars were only 32mm. This effectively weakened the join.

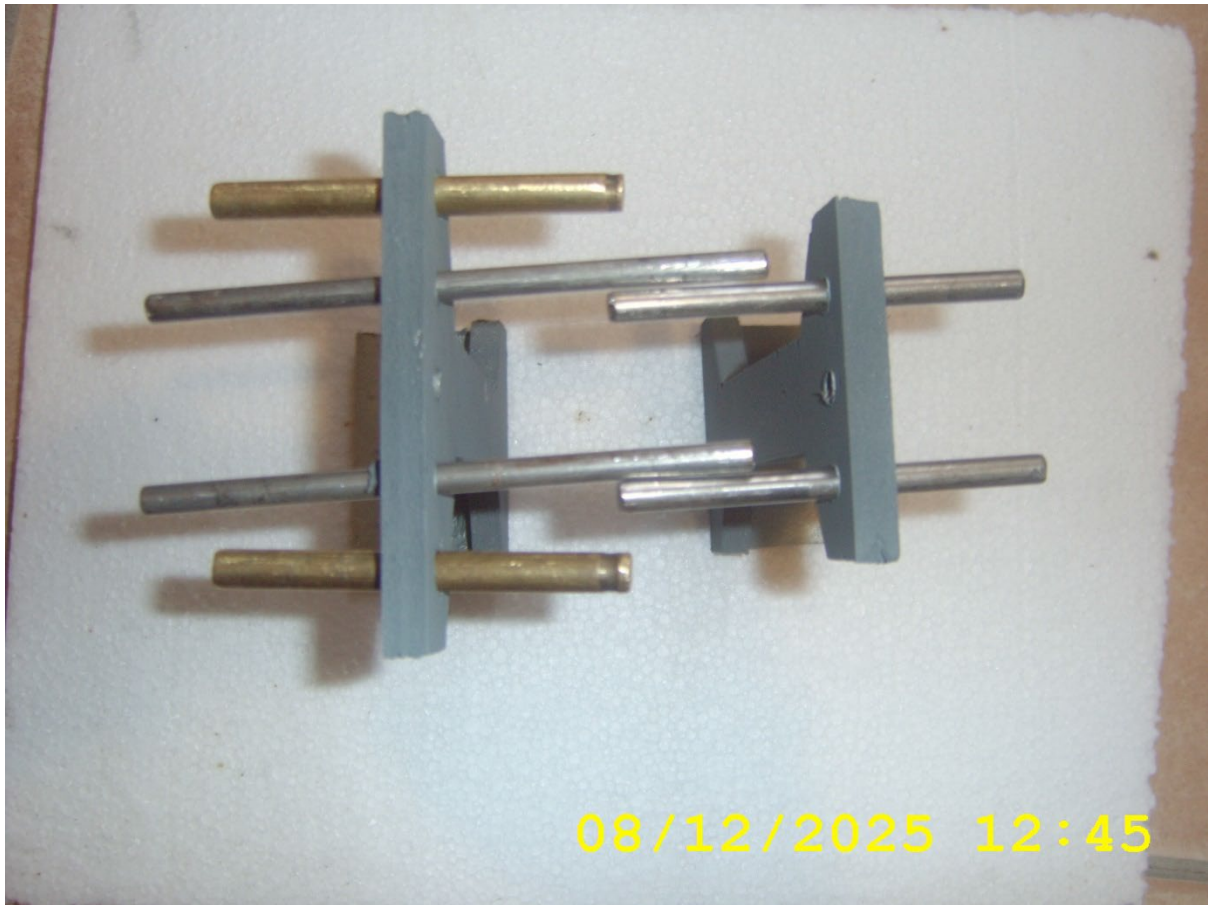
This next photo shows how the lengths of rebar were overlapped to form the join.

I have removed the centre bar to make it easier to understand the join

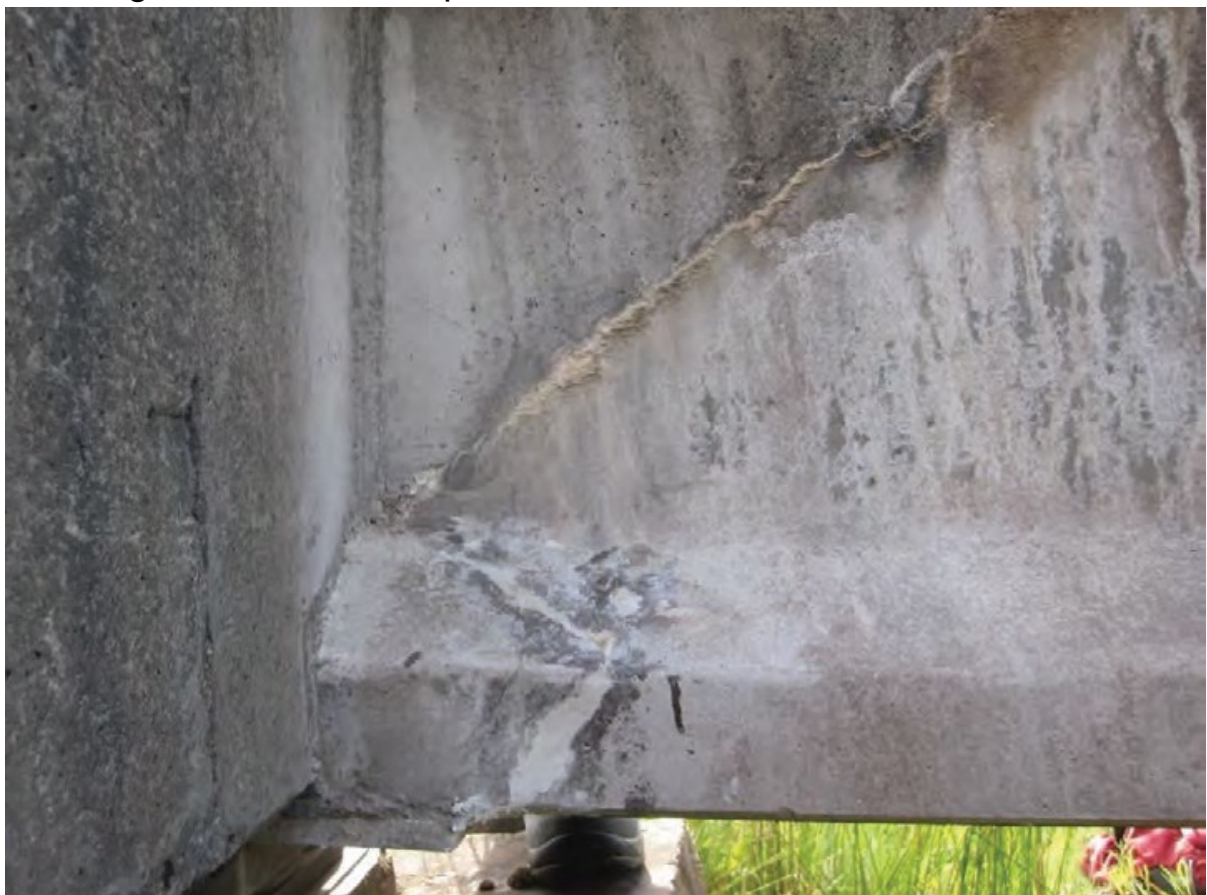
(photo courtesy of COWI report Dec 2018)

Some of the repair works include brackets around the insitu joints. These are an attempt to compensate for the lack of the correct couplings and also to support the ends of the concrete “I” beams to stop them from breaking off as in the next photo.

I sent a picture of an “I” beam to a mould and beam manufacturer with 36years experience. His first comment was that the end of the beam would snap!!

These brackets will need continuous inspection to make sure that the tension in them is maintained at the required level.

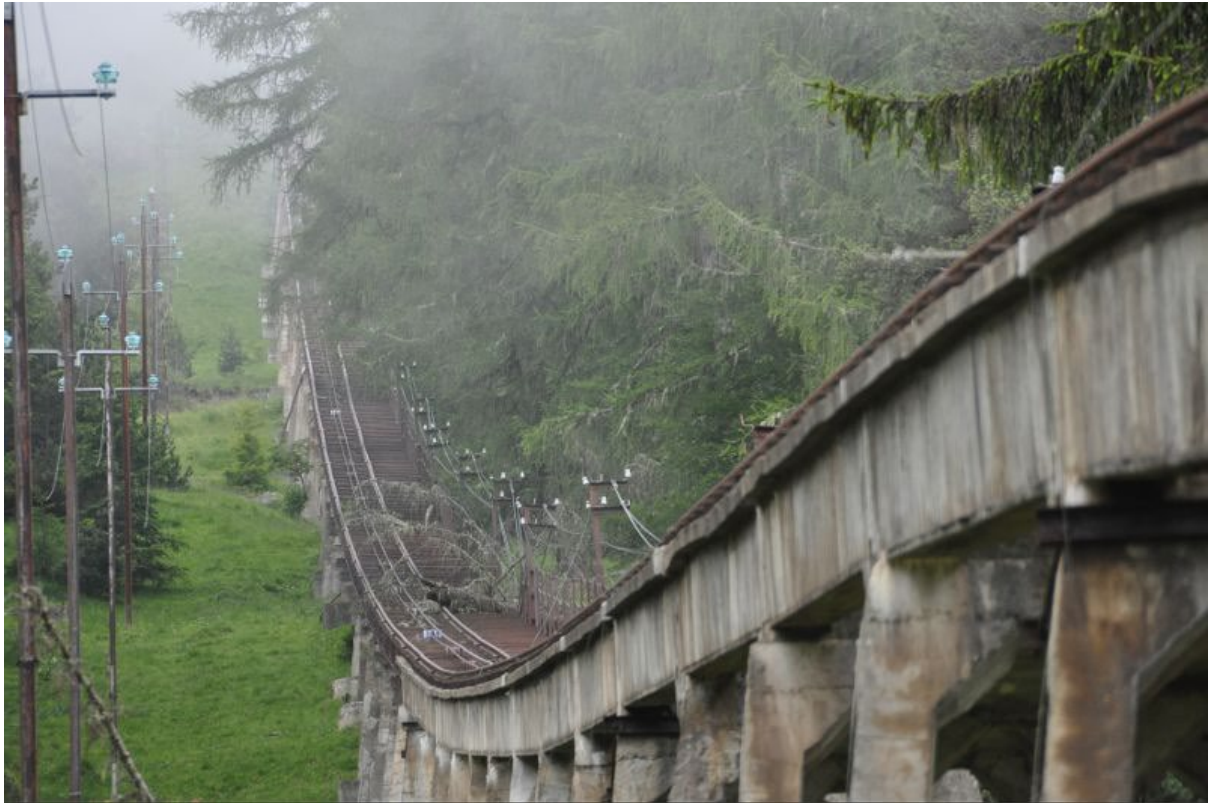
The next picture was sent to me by the magazine "FUNIMAG".

I visited it in 2014 and I am sure the concrete elements are still in good condition without any steel brackets

Closer examination of the structure shows that some of the supporting "I" beams are steel with others of concrete, but the width of those concrete beams is far greater than the Cairn Gorm funicular

Note that, despite its 65 years of use and 25 years standing idle, there are no steel brackets holding it together.
